Allied Paper, Inc./Portage Creek/Kalamazoo River Superfund Site  
King Highway Landfill Operable Unit 3  
Completed Repairs to the King Highway Landfill Final Cover System

October 25, 2012

Figure 1 – Stressed Vegetation and Geomembrane Liner Repair Locations  
Attachment A – Photo Log

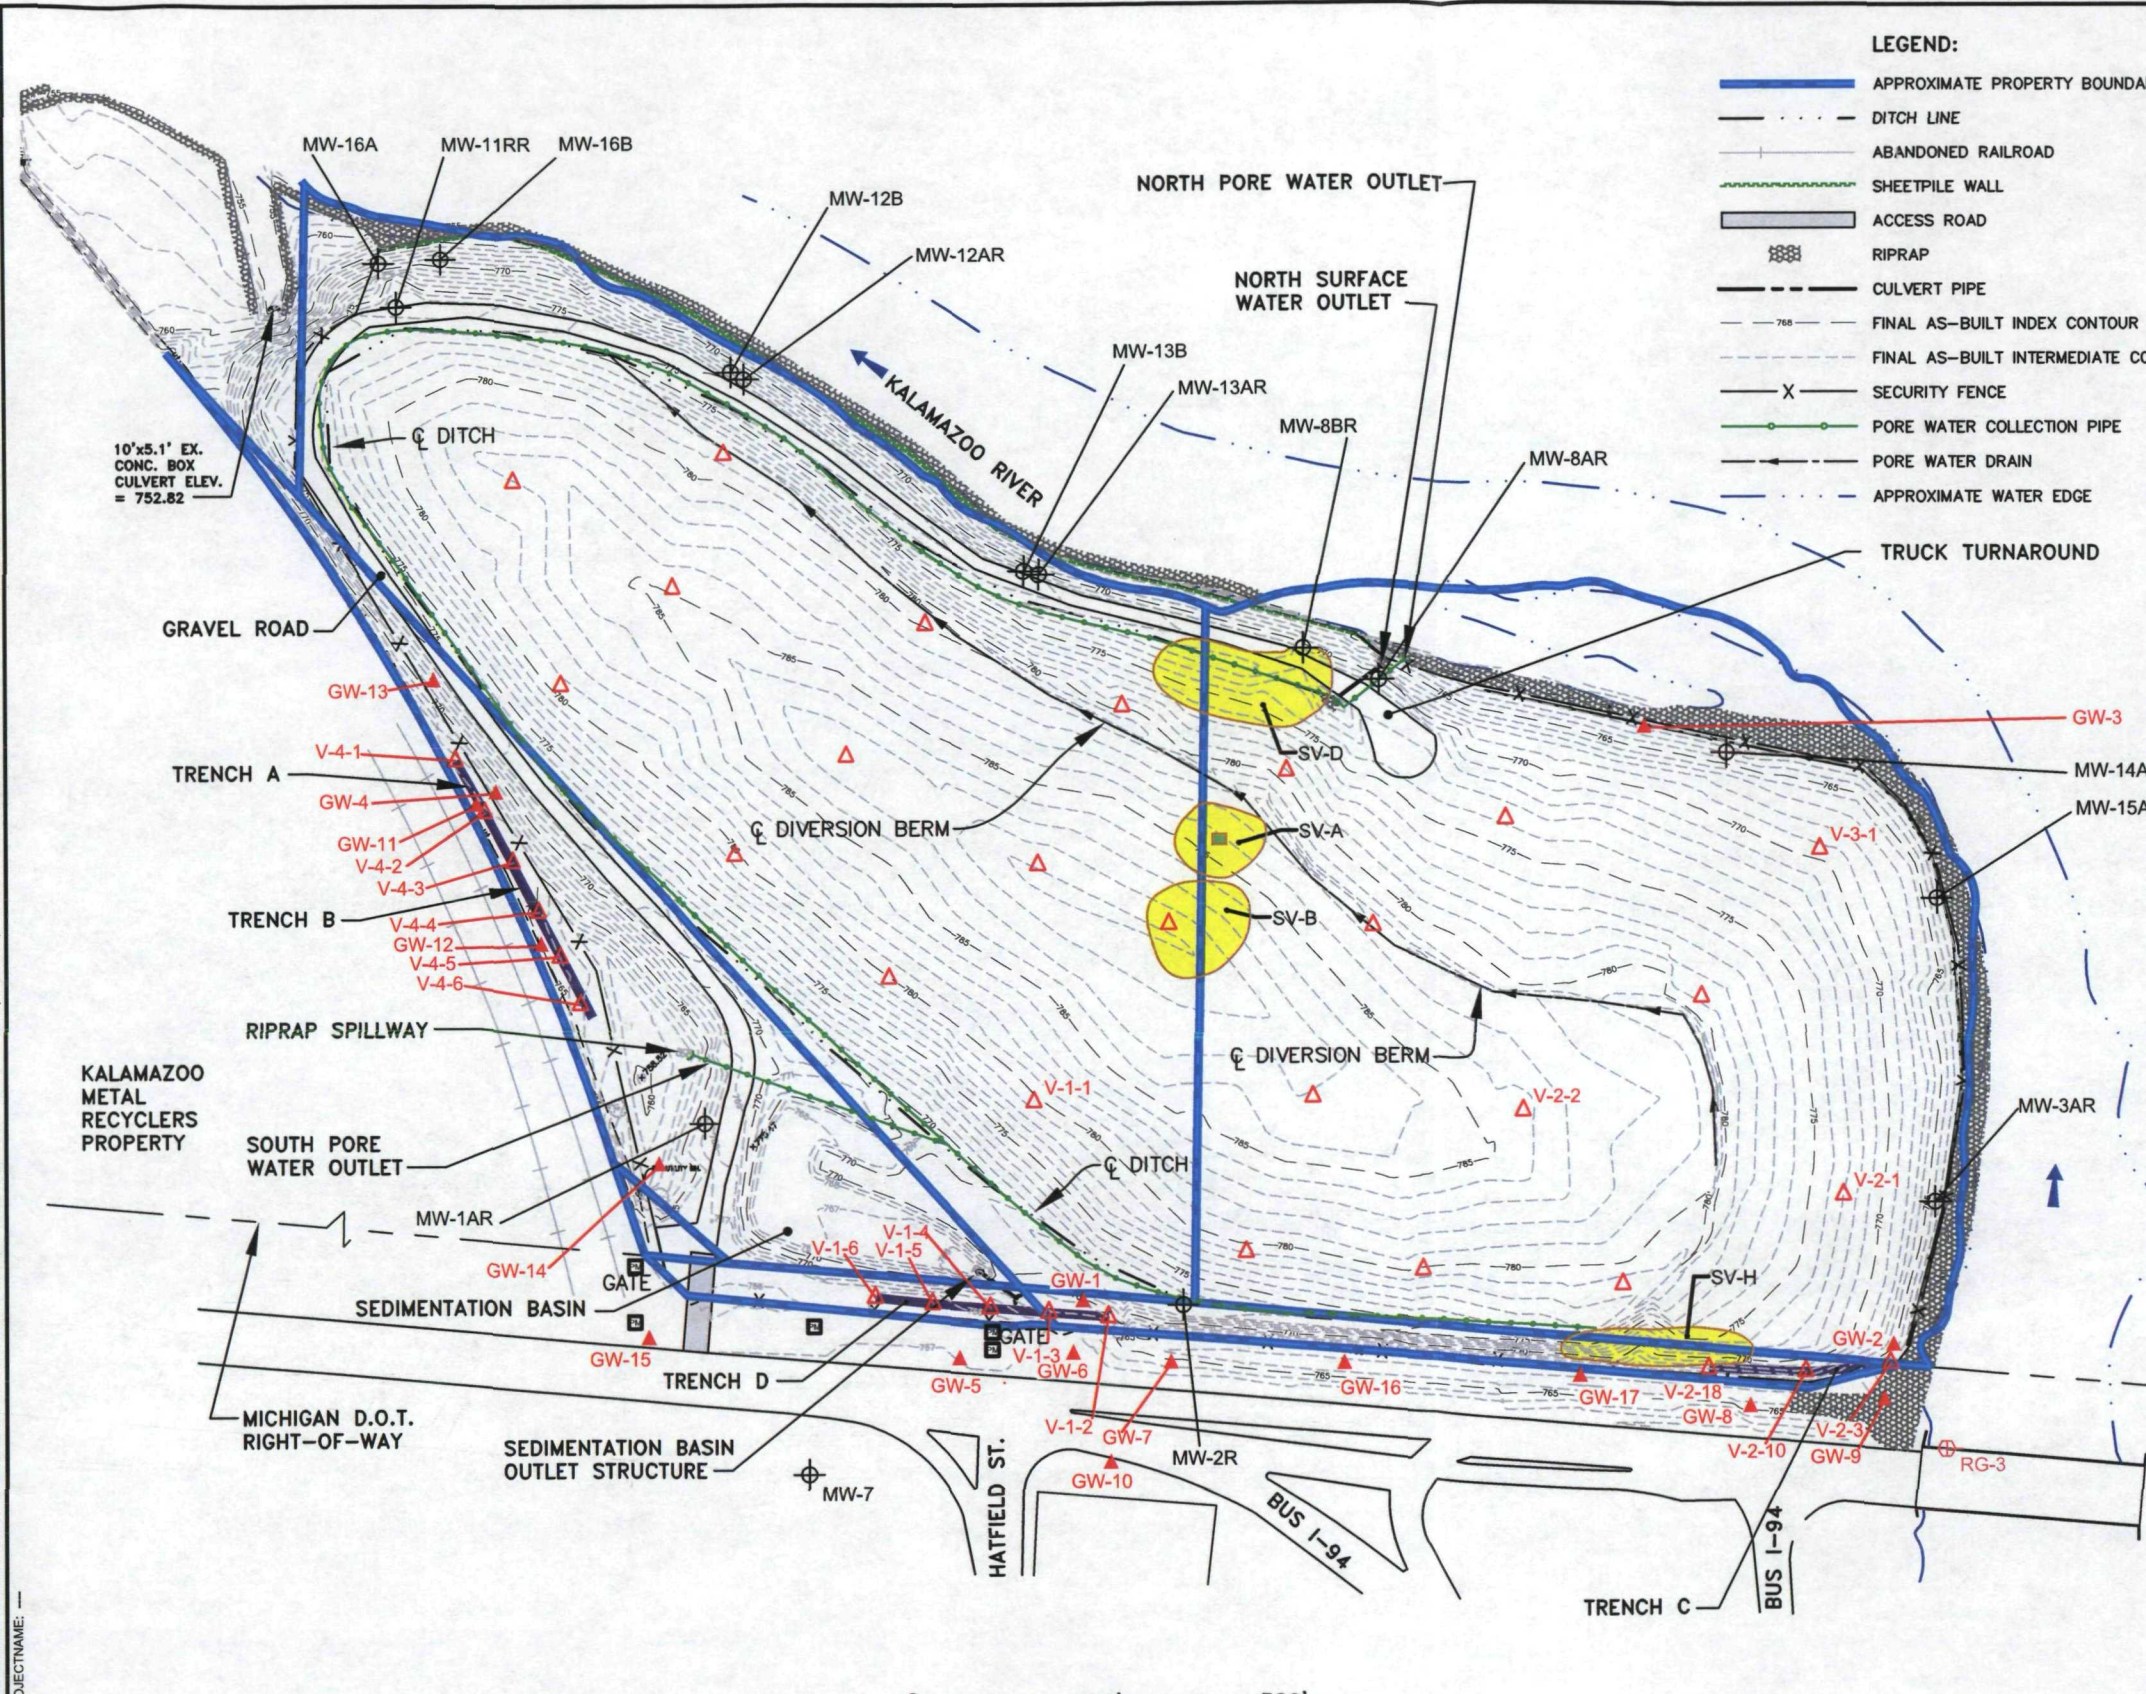
FIGURE  
1

Repair activities were performed according to the June 27, 2012 *Stressed Vegetation Sampling Results and Work Plan* (Work Plan), which was approved by MDEQ via an email message on July 3, 2012. The Work Plan provided sample results from observed stressed vegetation within the final cover system of the KHL and proposed corrective measures to be implemented based on the sample results. The corrective measures included removal of a portion of the final cover soils; inspection of the existing 40 mil linear low-density polyethylene (LLDPE) geomembrane liner; repair of any observed breaches in the geomembrane liner; if necessary, replacement of cover soils; placement of imported topsoil, seed, mulch, and fertilize as needed to establish vegetative growth; and repair of several other areas of observed stressed vegetation through the placement of imported topsoil, seed, mulch, and fertilize as needed to establish vegetative growth. Areas of stressed vegetation are shown on Figure 1.

STRESSED VEGETATION AND  
GEOMEMBRANE LINER REPAIR LOCATIONS

- GAS VENTS (ORIGINAL 23; ONLY FOUR WERE GIVEN IDS)
- CUTOFF TRENCH GAS VENTS
- LANDFILL GAS CUTOFF TRENCH
- FLOW DIRECTION
- MONITORING WELL
- RIVER GAUGE STATION
- LOCATION OF GAS MONITORING PROBES
- APPROXIMATE LOCATION OF REPAIRED STRESSED VEGETATION OR AREA OF HYDRO-EXCAVATION BACKFILLED WITH GENERAL FILL AND TOPSOIL
- APPROXIMATE LOCATION OF BREACH IN GEOMEMBRANE LINER PATCHED WITH NEW 40 MIL LLDPE

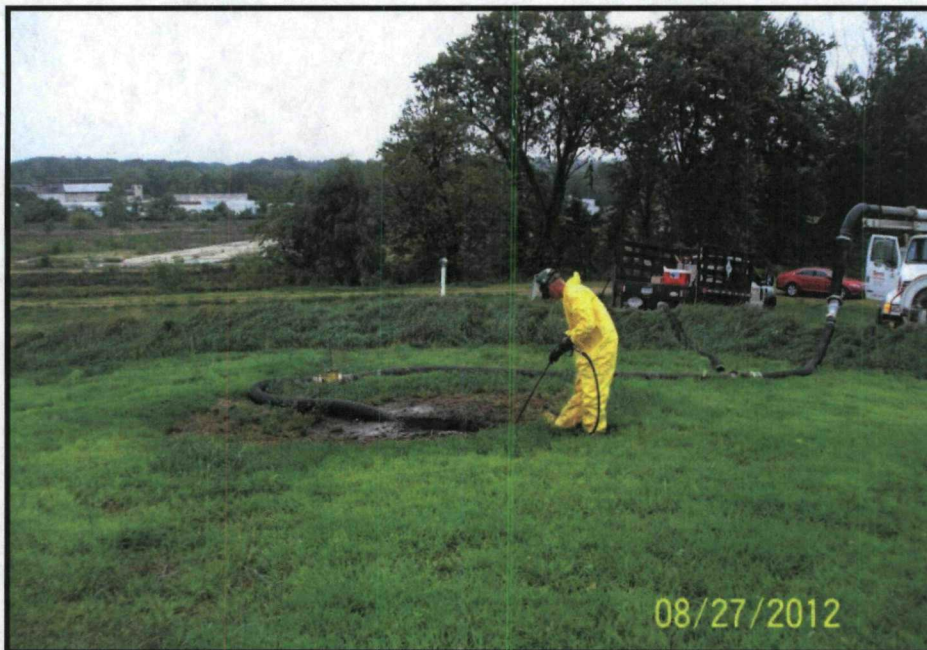
Terra began repair activities by hydro-excavating an approximate 12-foot by 15-foot area around stressed vegetation area SV-A (refer to Figure 1) where previous soil gas sampling conducted within the area resulted in methane detected above the lower explosive limit. The area was hydro-excavated down to the existing 40 mil LLDPE geomembrane liner, as depicted in Photo 1 in Attachment A. Once the existing geomembrane liner was unearthed, a tear and several small holes were observed in the geomembrane liner, within an approximate 9-foot by 12-foot area of the liner. Chesapeake Containment Systems, Inc. (Chesapeake; the geomembrane liner installation subcontracted to Terra) inspected the breach in the existing liner and determined that the breach could be patched with new 40 mil LLDPE geomembrane liner acquired from the Willow Boulevard/A-Site Operable Unit (WB/A-Site OU) construction project, which met quality controls required for the WB/A-Site OU construction project.

Photo No. 1: Hydro-excavation of stressed vegetation area SV-A  
(Location depicted on Figure 1).

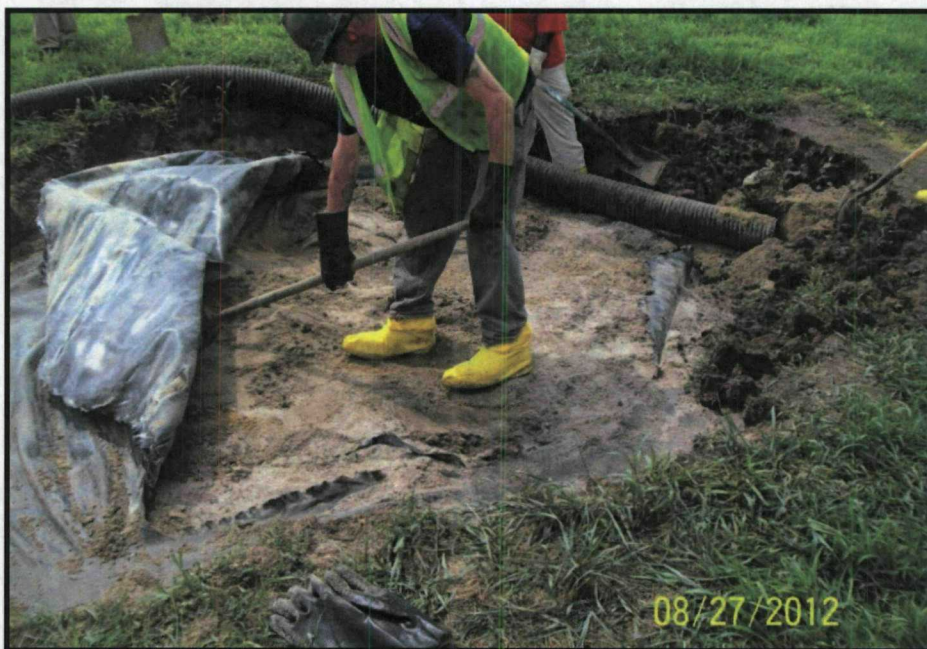
Photo No. 2: Hand digging stressed vegetation area SV-A and breach in  
existing 40 mil LLDPE geomembrane liner.

On August 28, 2012, Chesapeake removed the damaged portion of the existing 40 mil LLDPE geomembrane liner (an approximate 9-foot by 12-foot area) from SV-A (refer to Photos 2 and 3 in Attachment A), and prepared a patch from the new 40 mil LLDPE geomembrane liner. Chesapeake then welded the new patch of geomembrane liner to the existing 40 mil LLDPE geomembrane liner using an extrusion welder (refer to Photos 4 and 5 in Attachment A). Once the patch was welded to the existing geomembrane liner, Chesapeake vacuum box tested the welded patch seams to verify that the welds were sufficient to resist leakage.

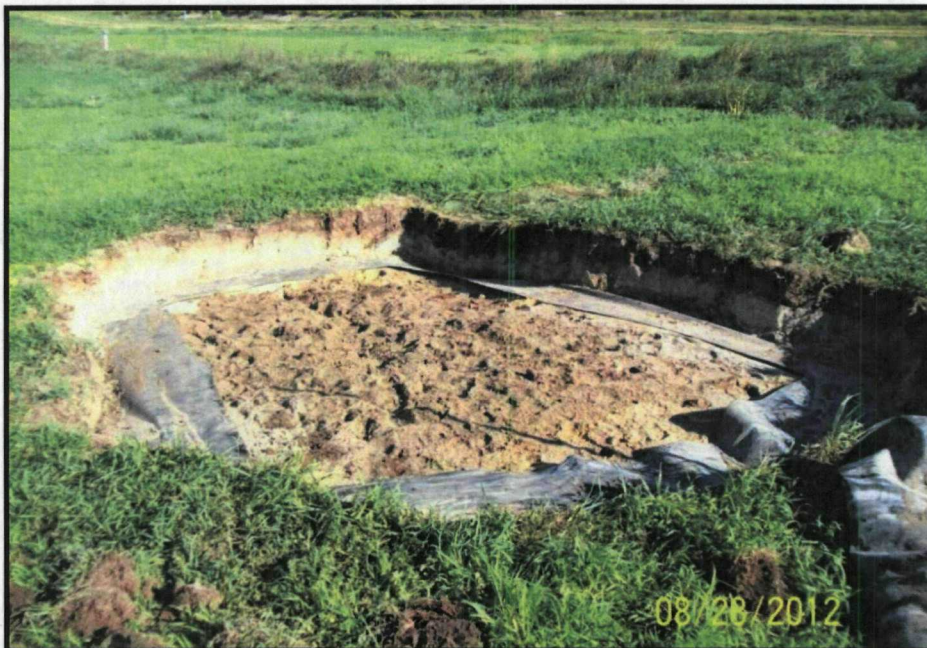
Photo No. 3: Breach in 40 mil LLDPE geomembrane liner within stressed vegetation area SV-A.

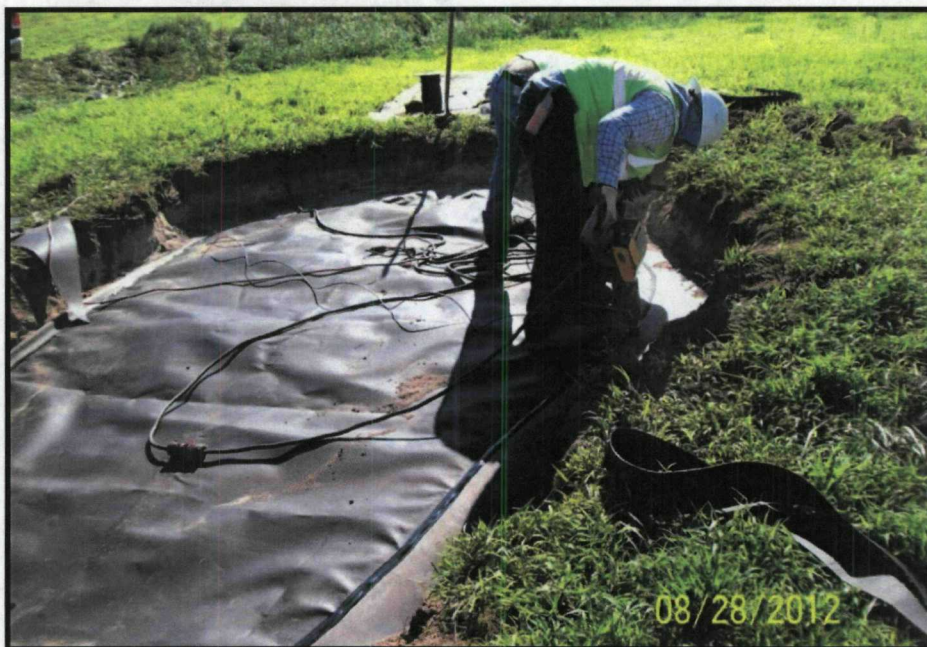
Photo No. 4: Chesapeake Containment Systems, Inc. welding the patch over the breach to the existing 40 mil LLDPE geomembrane liner at SV-A.

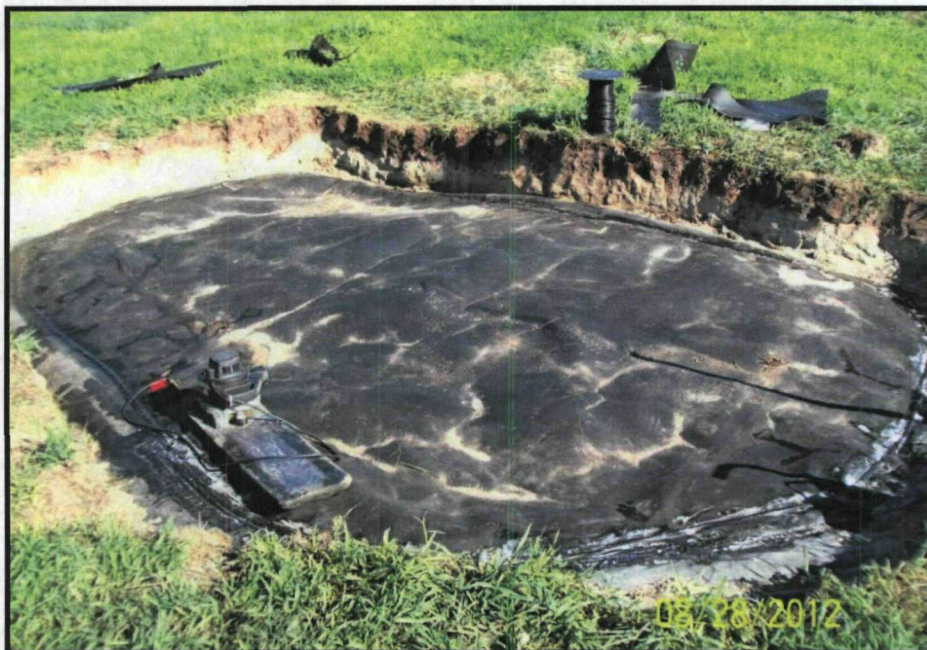
Photo No. 5: New 40 mil LLDPE geomembrane liner patch welded over breach in existing 40 mil LLDPE geomembrane liner at SV-A.

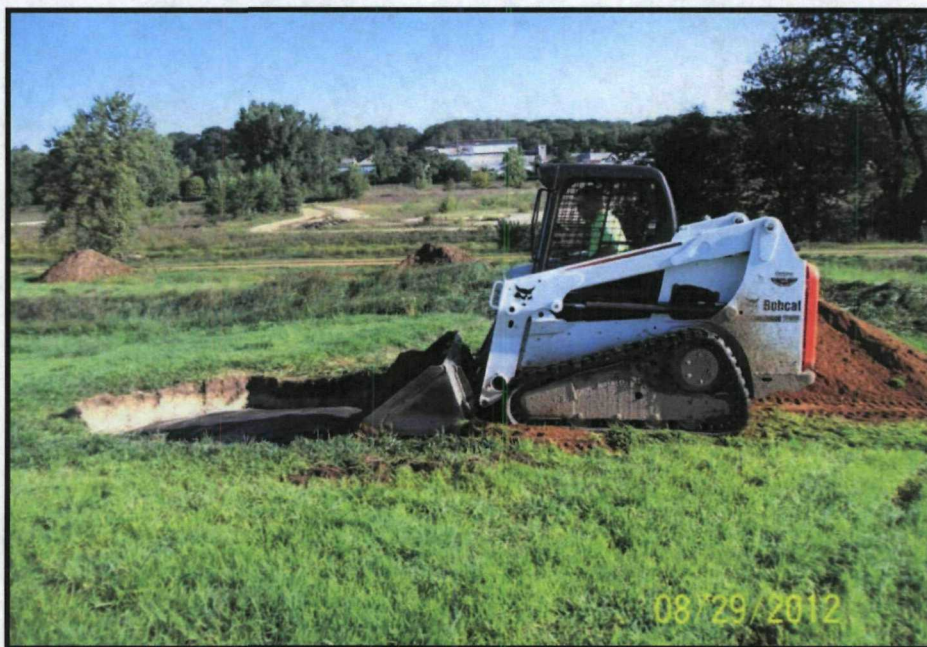
Photo No. 6: Backfilling general fill over the repaired 40 mil LLDPE geomembrane liner within stressed vegetation area SV-A.

On August 29, 2012, Terra placed backfill in stressed vegetation area SV-A over the patched geomembrane liner; the backfill included a 24-inch thick layer of general fill followed by a 6-inch thick layer of topsoil (refer to Photos 6 through 8 in Attachment A) imported from the WB/A-Site OU construction project. General fill and topsoil materials met quality controls required for the WB/A-Site OU construction project. Terra prepared the backfilled area for seeding by grading the area with a landscape rake. Terra also placed topsoil and regraded the low-lying area in the drainage swale along the northern access road where ponding was previously observed (SV-D) (refer to Photo 9 in Attachment A).

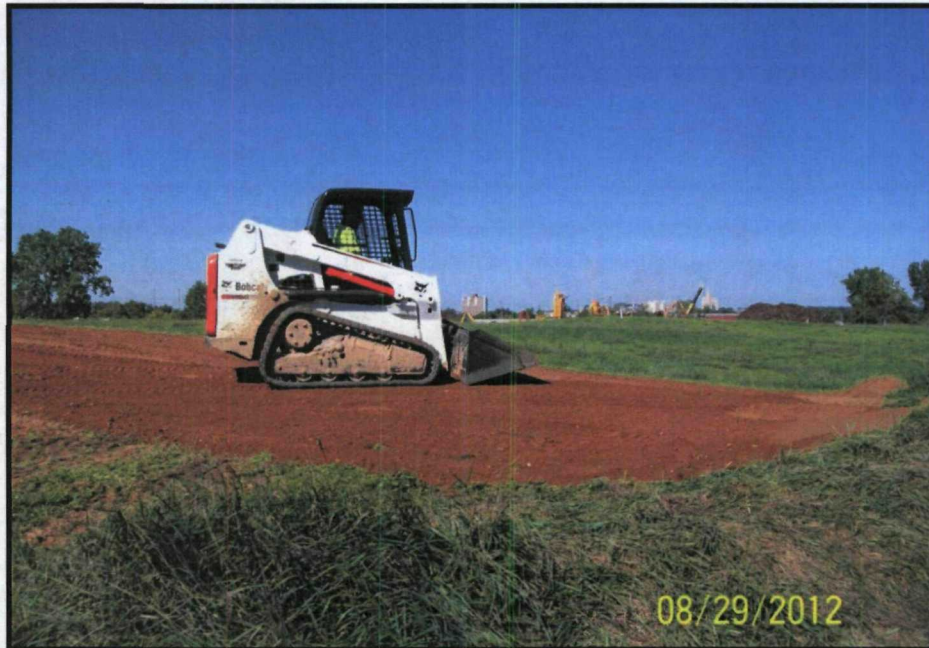
Photo No. 7: Placement of a 24-inch layer of general fill over the repaired 40 mil LLDPE geomembrane liner within stressed vegetation area SV-A.

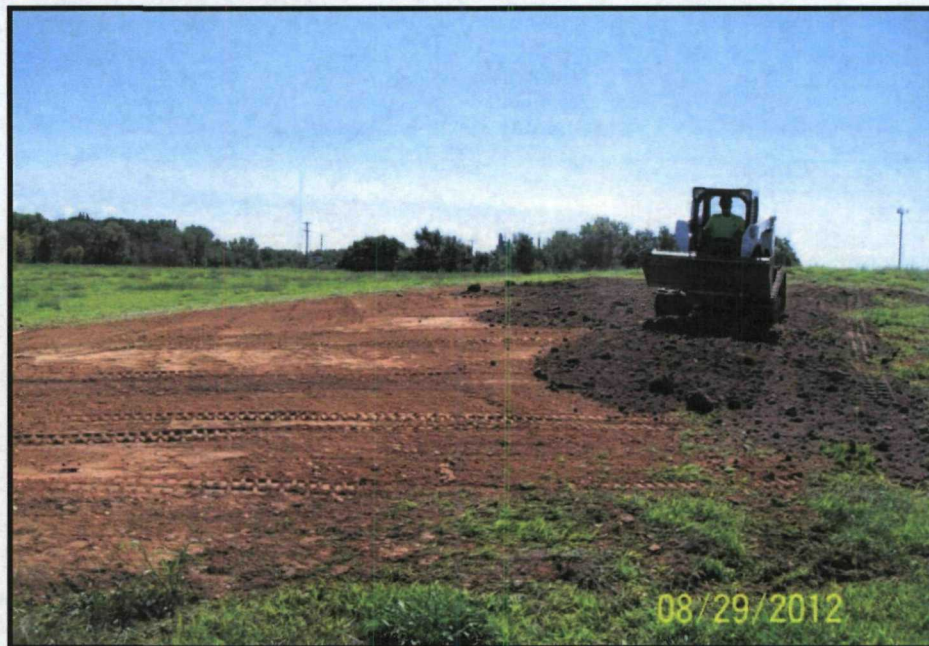
Photo No. 8: Placement of 6-inches of topsoil over a 24-inch-thick layer of general fill within stressed vegetation area SV-A.

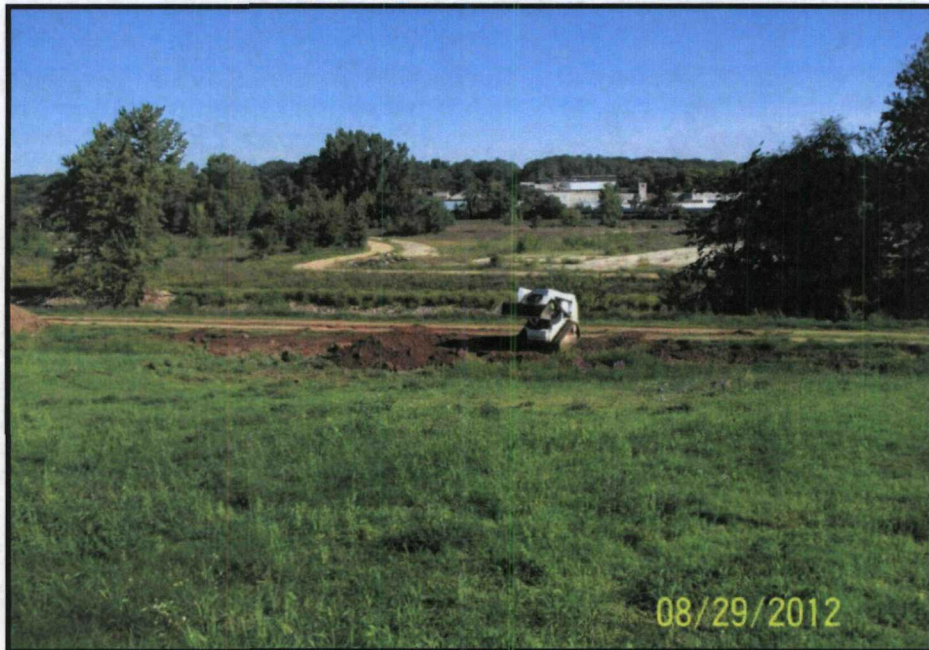
Photo No. 9: Placement of topsoil and grading of the low-lying area in the drainage swale along the north access road where ponding water was previously observed (SV-D; Located depicted on Figure 1).

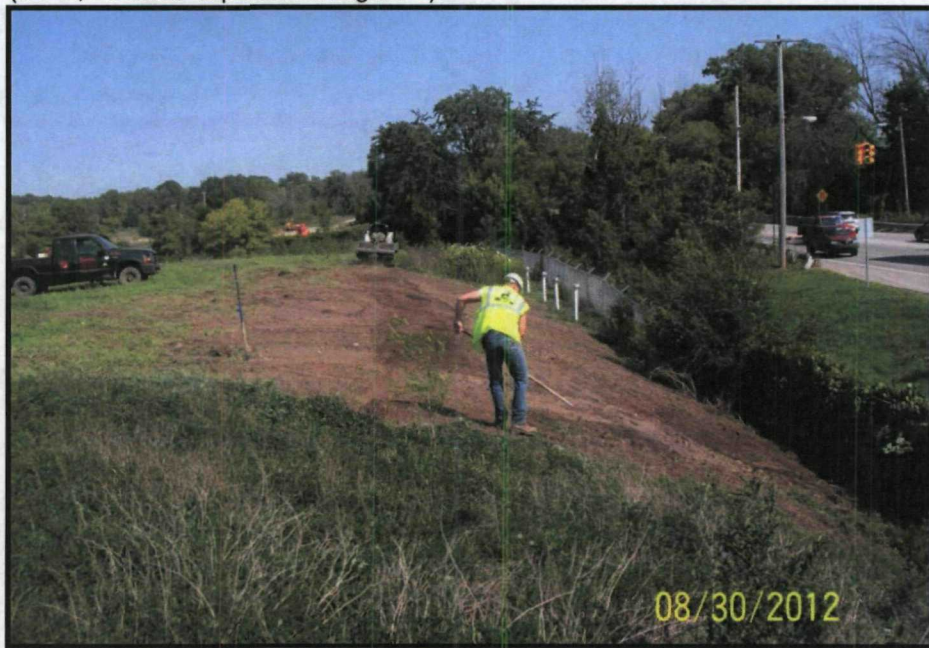
Photo No. 10: Placement of topsoil and grading of stressed vegetation area SV-H (Located depicted on Figure 1).

On August 30, 2012, Terra placed topsoil and regraded stressed vegetation area SV-B (*immediately south of stressed vegetation area SV-A*) and SV-H (*at the southeast corner of the site*) (refer to Photo 10 in Attachment A).

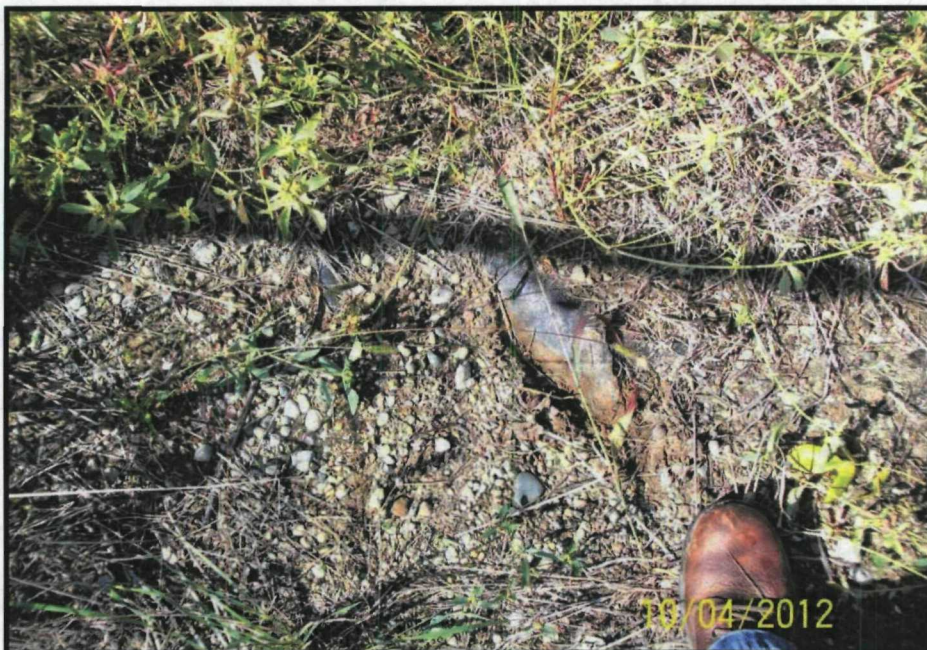
Photo No. 11: Area of exposed geotextile at the southeast corner of the King Highway Landfill.

Additionally, on October 4, 2012, ARCADIS completed maintenance activities associated with the area of exposed geotextile (approximately 4 foot by 1 foot) located at the southeast corner of the landfill, immediately north of landfill gas cutoff trench (Trench C). This patch of exposed geotextile was determined not to be associated with the geomembrane liner of the final cover system. A 4-inch thick layer of topsoil was placed over the area of exposed geotextile and the topsoil was seeded (with residual grass seed from the aforementioned stressed vegetation repair activities) and mulched to facilitate vegetative growth. Refer to Photos 11 and 12 included in Attachment A.

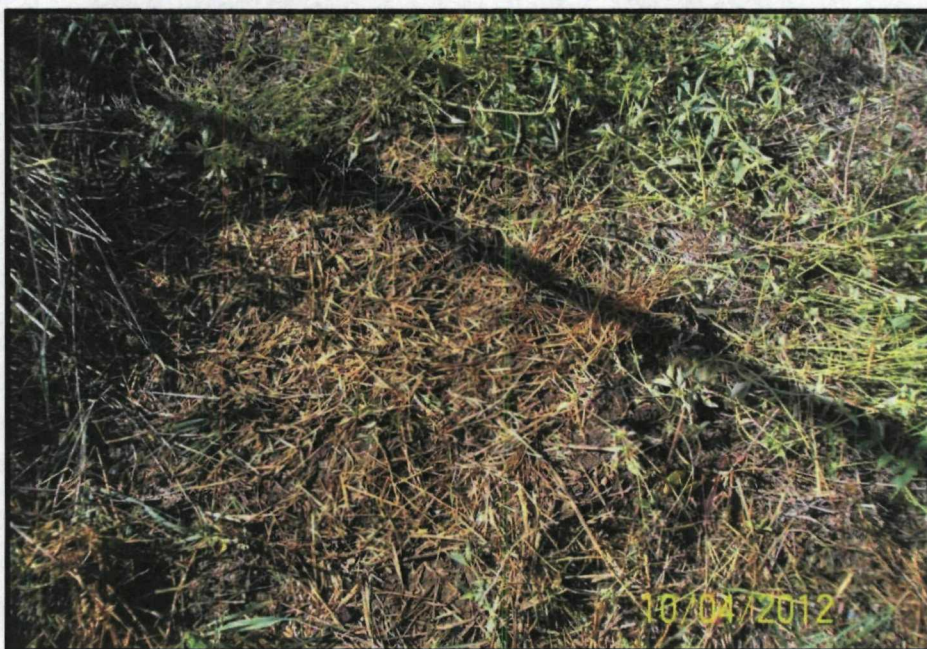
Photo No. 12: Completed repairs to the area of exposed geotextile at the southeast corner of the King Highway Landfill.
